IN FOCUS: Mechanical Repairs

INNOVATIONS IN METAL REBUILDING

Issue 110

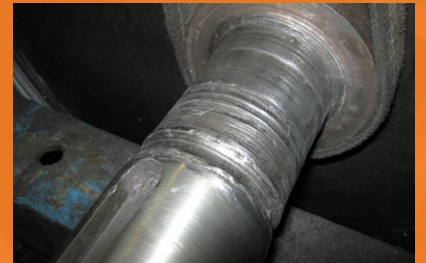
Wear and Corrosion 1

Damaged mechanical elements can lead to premature failure...

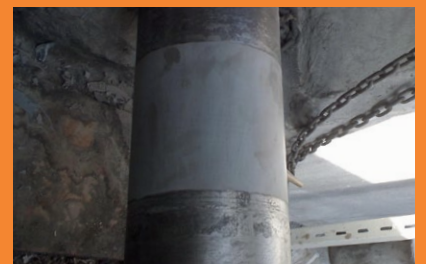
Shaft Restored In Situ 3

4 days of downtime avoided with a quick repair...

A large shaft on a rotary filter at a wastewater station in Egypt got worn over the years, leading to significant metal loss. The client was initially considering a traditional welding repair, which would require for the shaft to be disassembled. Welding also presents risks due to potential metal bending and distortion. In addition, due to the length of the shaft a special lathe would need to be brought in for machining, which was not readily available.

The shaft remained in situ throughout the repair process and the application of [Belzona 1111](#) was completed in less than 5 hours with the use of prefabricated formers. The surface was manually prepared, then Belzona applied and the formers fitted to restore exact surface profile. [Belzona 1111](#) is 100% solids and does not shrink during cure, which makes it ideal for rapidly restoring metal loss in situ.

The repaired shaft has now been in service for over 7 years with no issues. In fact, Belzona repairs can last for 20 or more years depending on service conditions and have been known to outlast the original design life of the shaft. ■

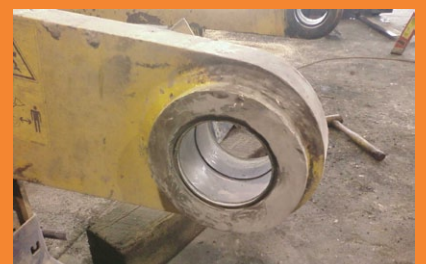
Housing Rebuilt 4

Repairs completed for 1/10th the cost of welding...

Belzona offered a cost- and time-saving alternative to conventional repair methods at a metals recycling facility in Missouri, USA. Wear affected the pin bush housing on a Komatsu Loader leading to metal loss and misalignment. These bushings are located where loader arms connect to the loader body. Conventional welding repair would require the loader to be out of service for a long period of time. The Belzona solution was chosen for its ability to minimise downtime, while also providing a lasting solution.

[Belzona 1111 \(Super Metal\)](#) was applied onto the steel substrate and the dummy shaft installed to ensure precise alignment. Repairs were completed for 1/10th the cost of welding and line boring, and the loader was returned to service the next day. The Belzona Technical Consultant was on site to provide training and supervise the repair carried out by the customer's maintenance crew. The client was pleased with the Belzona solution and continues to use Belzona materials for their maintenance needs. ■

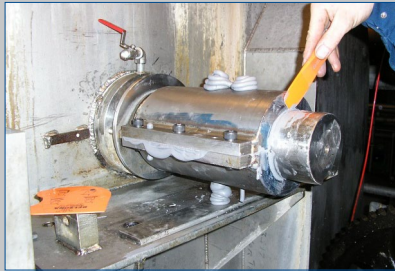
Forming

For this method of repair, suitable formers should be fabricated from rigid materials and split longitudinally. They should be of a suitable length to centralise the repair onto undamaged sections of the shaft. Vent holes and, where injection techniques are being utilised, injection ports should be drilled at strategic points.

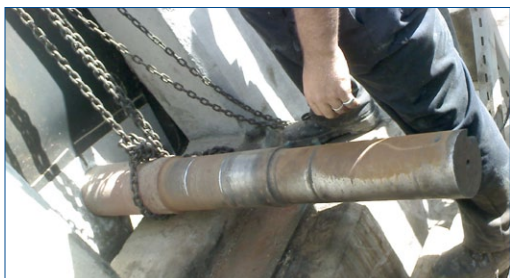
Worn shaft

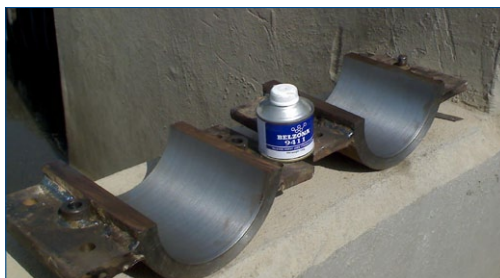
Former prepared

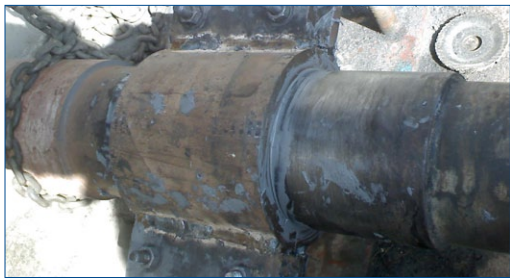
Belzona applied, former in place

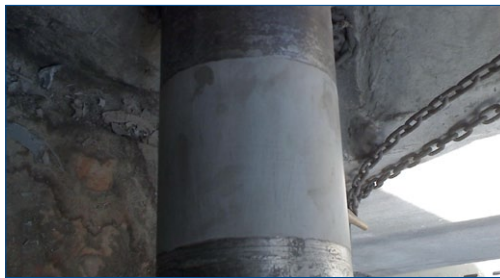
Completed application

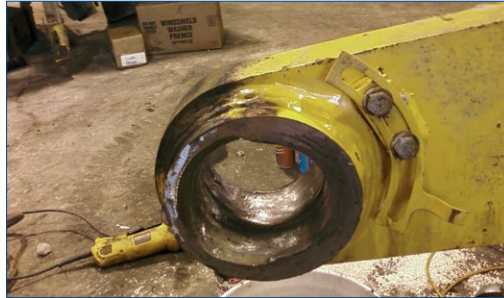
Damaged pin bush housing

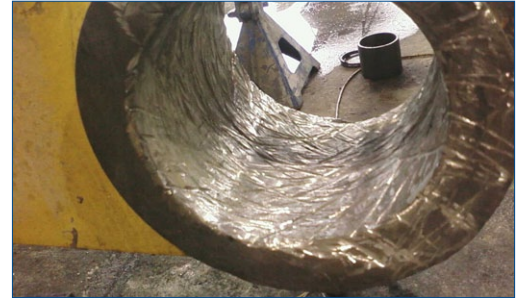
Surface preparation completed

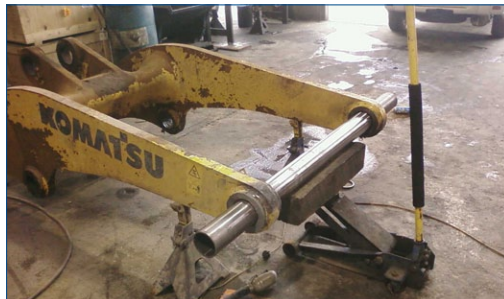
Dummy shaft installed to maintain alignment

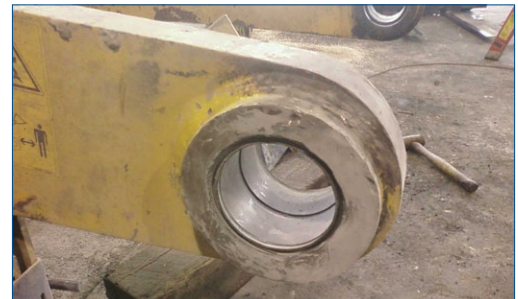
Finished application
